Manhole Inspection Summary

Manhole # S33CC2011MH

Insp Date: **10/27/08 4:27 PM**

Location Address: **PURLINGTON WAY**

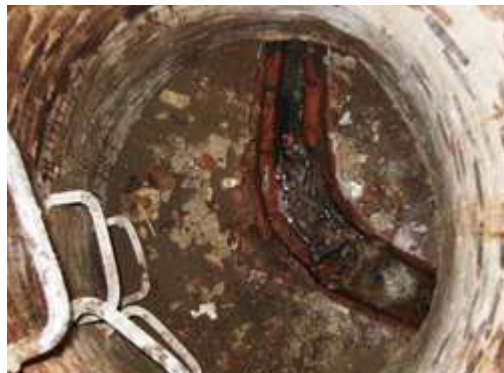
Top View

Evidence of surcharge - Bench debris.
Channel debris.

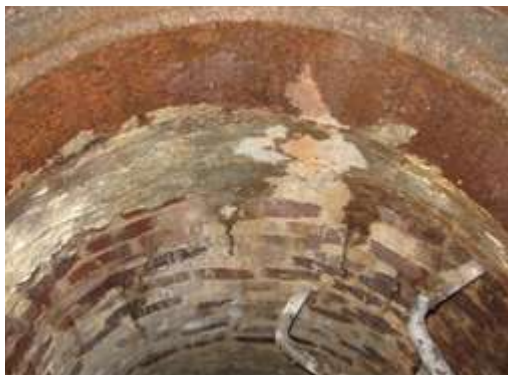
Defect

Adjustment and Barrel infiltration - other side.

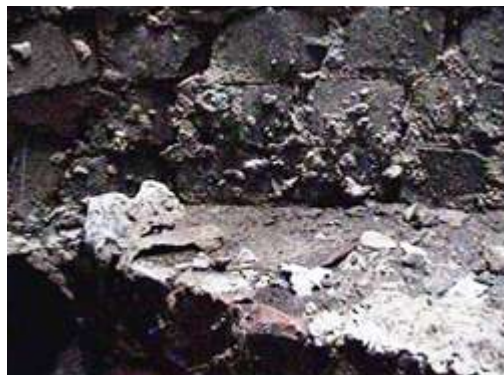
Defect

Barrel deterioration and infiltration.

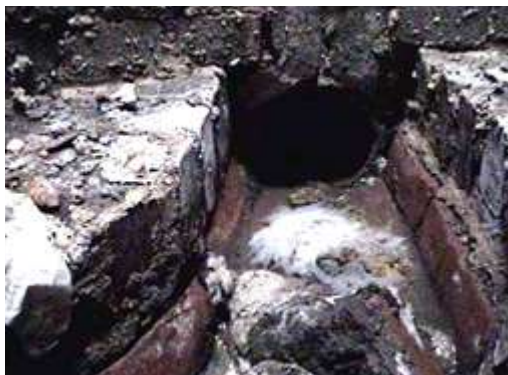
Defect

Channel deterioration and infiltration.

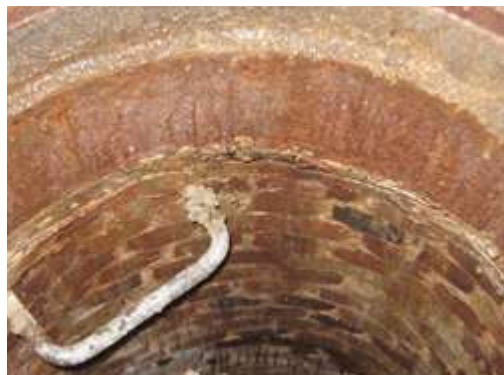
Defect

Adjustment and Barrel infiltration.

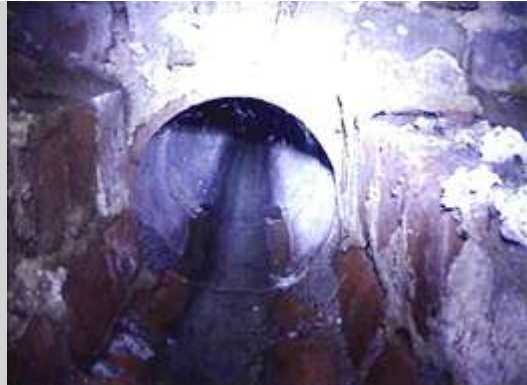
8 in. Circular Gravity Sewer Pipe Out @ 12 O'Clock

Infiltration: **Evidence** Pipe Seal Cond: **Unknown**

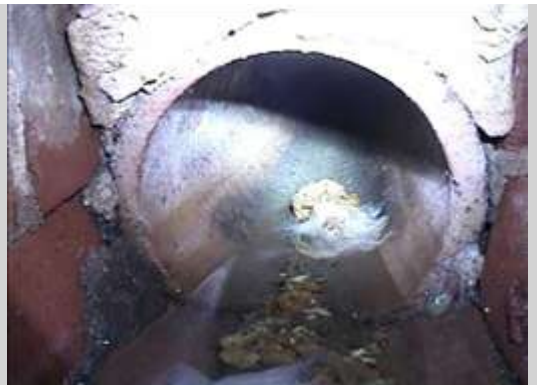
6 in. Circular Gravity Sewer Pipe In @ 3 O'Clock

Infiltration: **Evidence** Pipe Seal Cond: **Unknown**
